PROPERTY CONDITION REPORT

Commercial Building - APN 259-29-103
240 N Montgomery Street
San Jose, California 95110

March 13, 2018
Partner Project Number: 18-209196.1

Prepared for:
Trammell Crow Company
San Francisco, California 94111

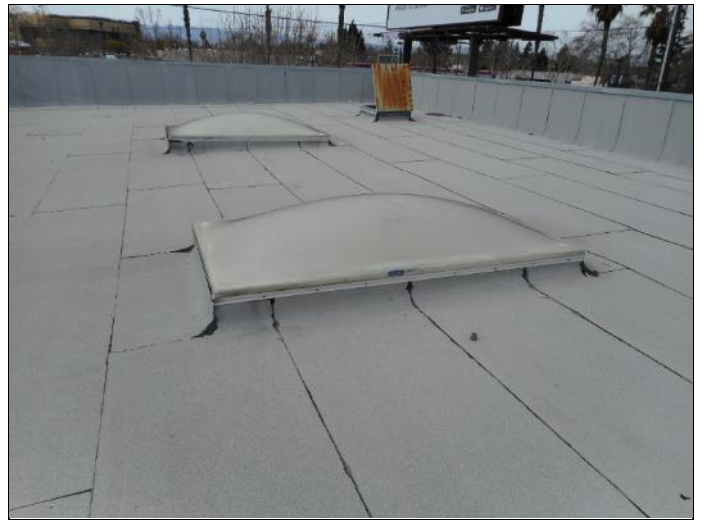
The roofing systems appeared to be in good overall condition. Based on EUL, reapplication of the roof coating is anticipated during the evaluation period with an opinion of the cost for this work included in Table 2.

10. Building 1 roof area

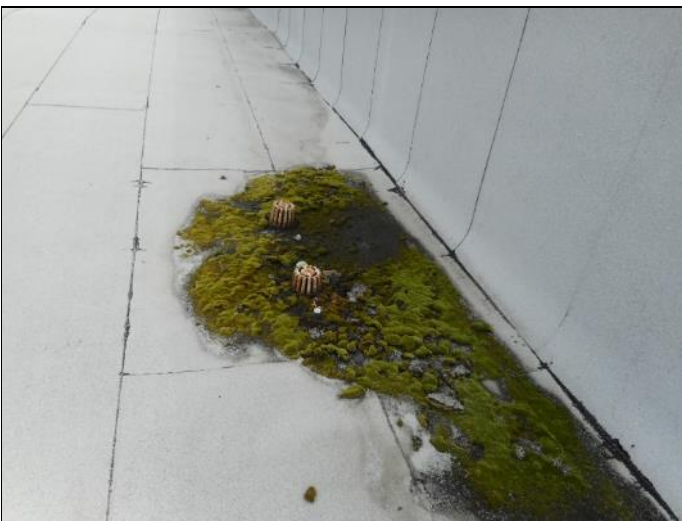
The roofing system on Building 1 was observed with clogged roof drains. The roof drains should be cleared free of debris. An opinion of cost for this work included in Table 1.

11. Roof drains

| Sect. No. | Deficiency or Repair Item | Quantity | Unit | Unit Cost | Total Cost |
|---|--|---|---|---|---|
| 4.4.1 | Roof repairs - The roofing system on Building 1 was observed with clogged roof drains. The roof drains should be cleared free of debris. | 1 | LS | \$1,500 | \$1,500 |
