**Subject: Los Gatos Creek Independent QC and Revisions to FINAL HEC-RAS model**

# TECHNICAL MEMORANDUM

**PROJECT:** Los Gatos Creek Modeling & Mapping

**SUBJECT:** 2D Hydraulic Model Details & Results Analysis  
(Update)

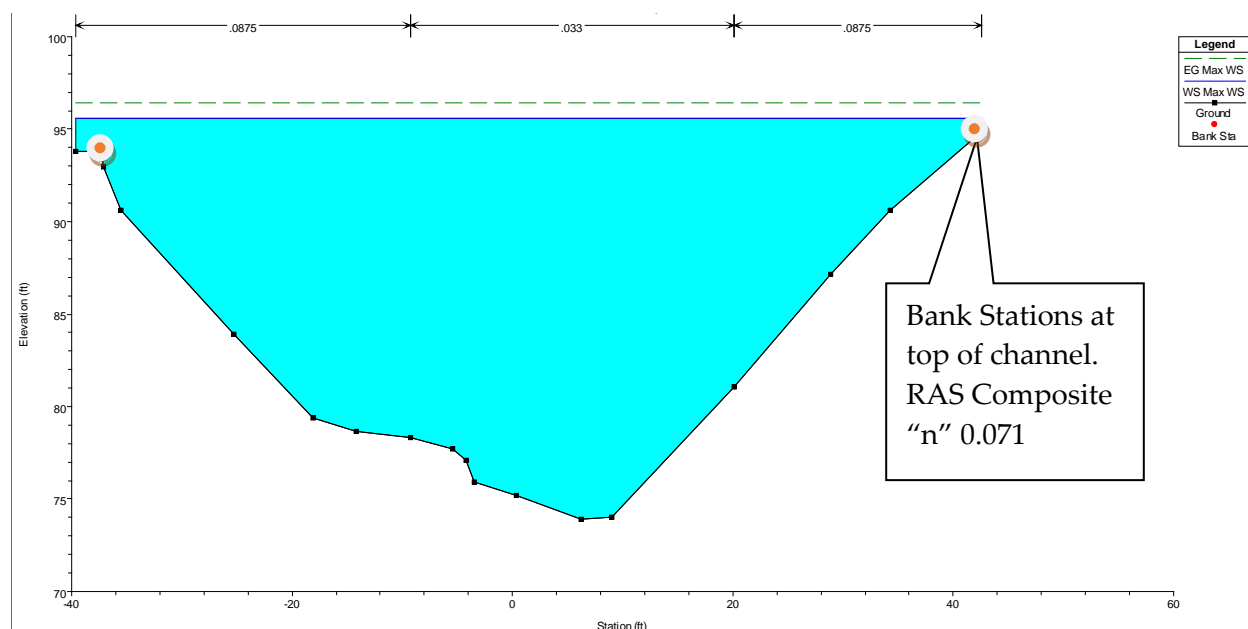
Figure 1: XS 2723 Downstream of Montgomery Road Culvert – Banks at Top

As the intent of the model is to run nearly bank full events, and banks at the low flow underestimate the influence of the vegetated slopes, banks at the top of the channel are considered to be the appropriate location. Additionally, the shape of the channel varies along the reach from Interstate 280 to the confluence but is generally trapezoidal with an incised low flow without prominent floodplain benches, which further supports placing model banks at the top of the channel. There is a significant difference in composite roughness when moving the model main channel bank stations from the low flow to the top of the channel with no other modifications as seen in Figures 1-4.

HEC-RAS defaults to compositing horizontally varied n-values for bank slopes greater than 5H:1V. Placing main channel bank stations at top of channel results in a high RAS composited n-value (example XS 5959 of 0.082 or XS 2723 of 0.071), which ranks at the high end of ten composite equations detailed in Appendix A. Note that RAS utilizes one of these ten equations which assumes each part of the cross sectional area has the same mean velocity and all are equal to the mean velocity of the whole section.<sup>1</sup> This assumption does not seem particularly valid with a widely varying roughness across the channel section. Placing bank stations at the top of the low flow channel calculates a low RAS composite Manning's "n". This results in high channel velocities generally above 10 ft/s and up to 16 ft/s<sup>2</sup>.

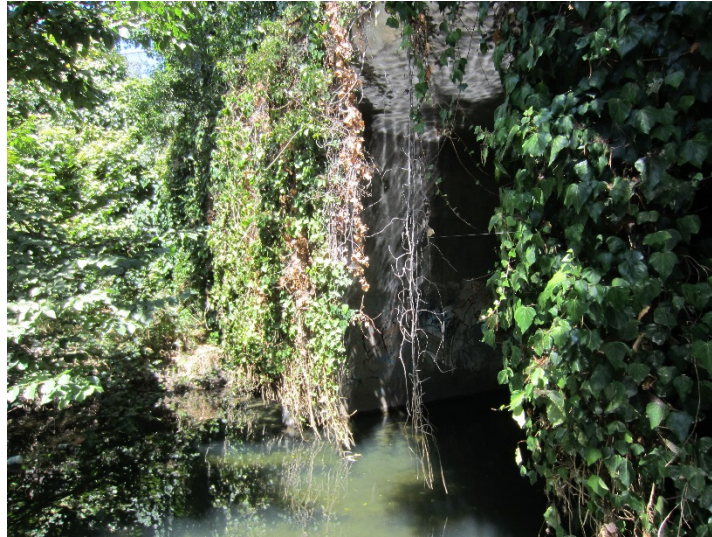
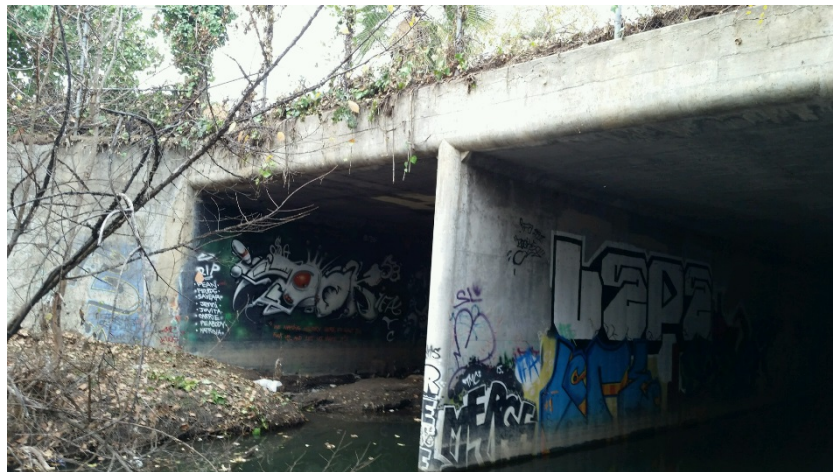
**Figure 2: Montgomery Street Culvert Vegetation (Before [Top] & After [Bottom])**

Since 2017, the District has since trimmed the vegetation hanging over the culvert. The 1D model geometry contains two cases – one with the 2017 condition of the vines, and one with the post-clearing. The 2D model, and subsequent flood mapping and results, will utilize the post-clearing scenario without the vines. Figure 2 below shows the extent of the vines, before and after vegetation removal.

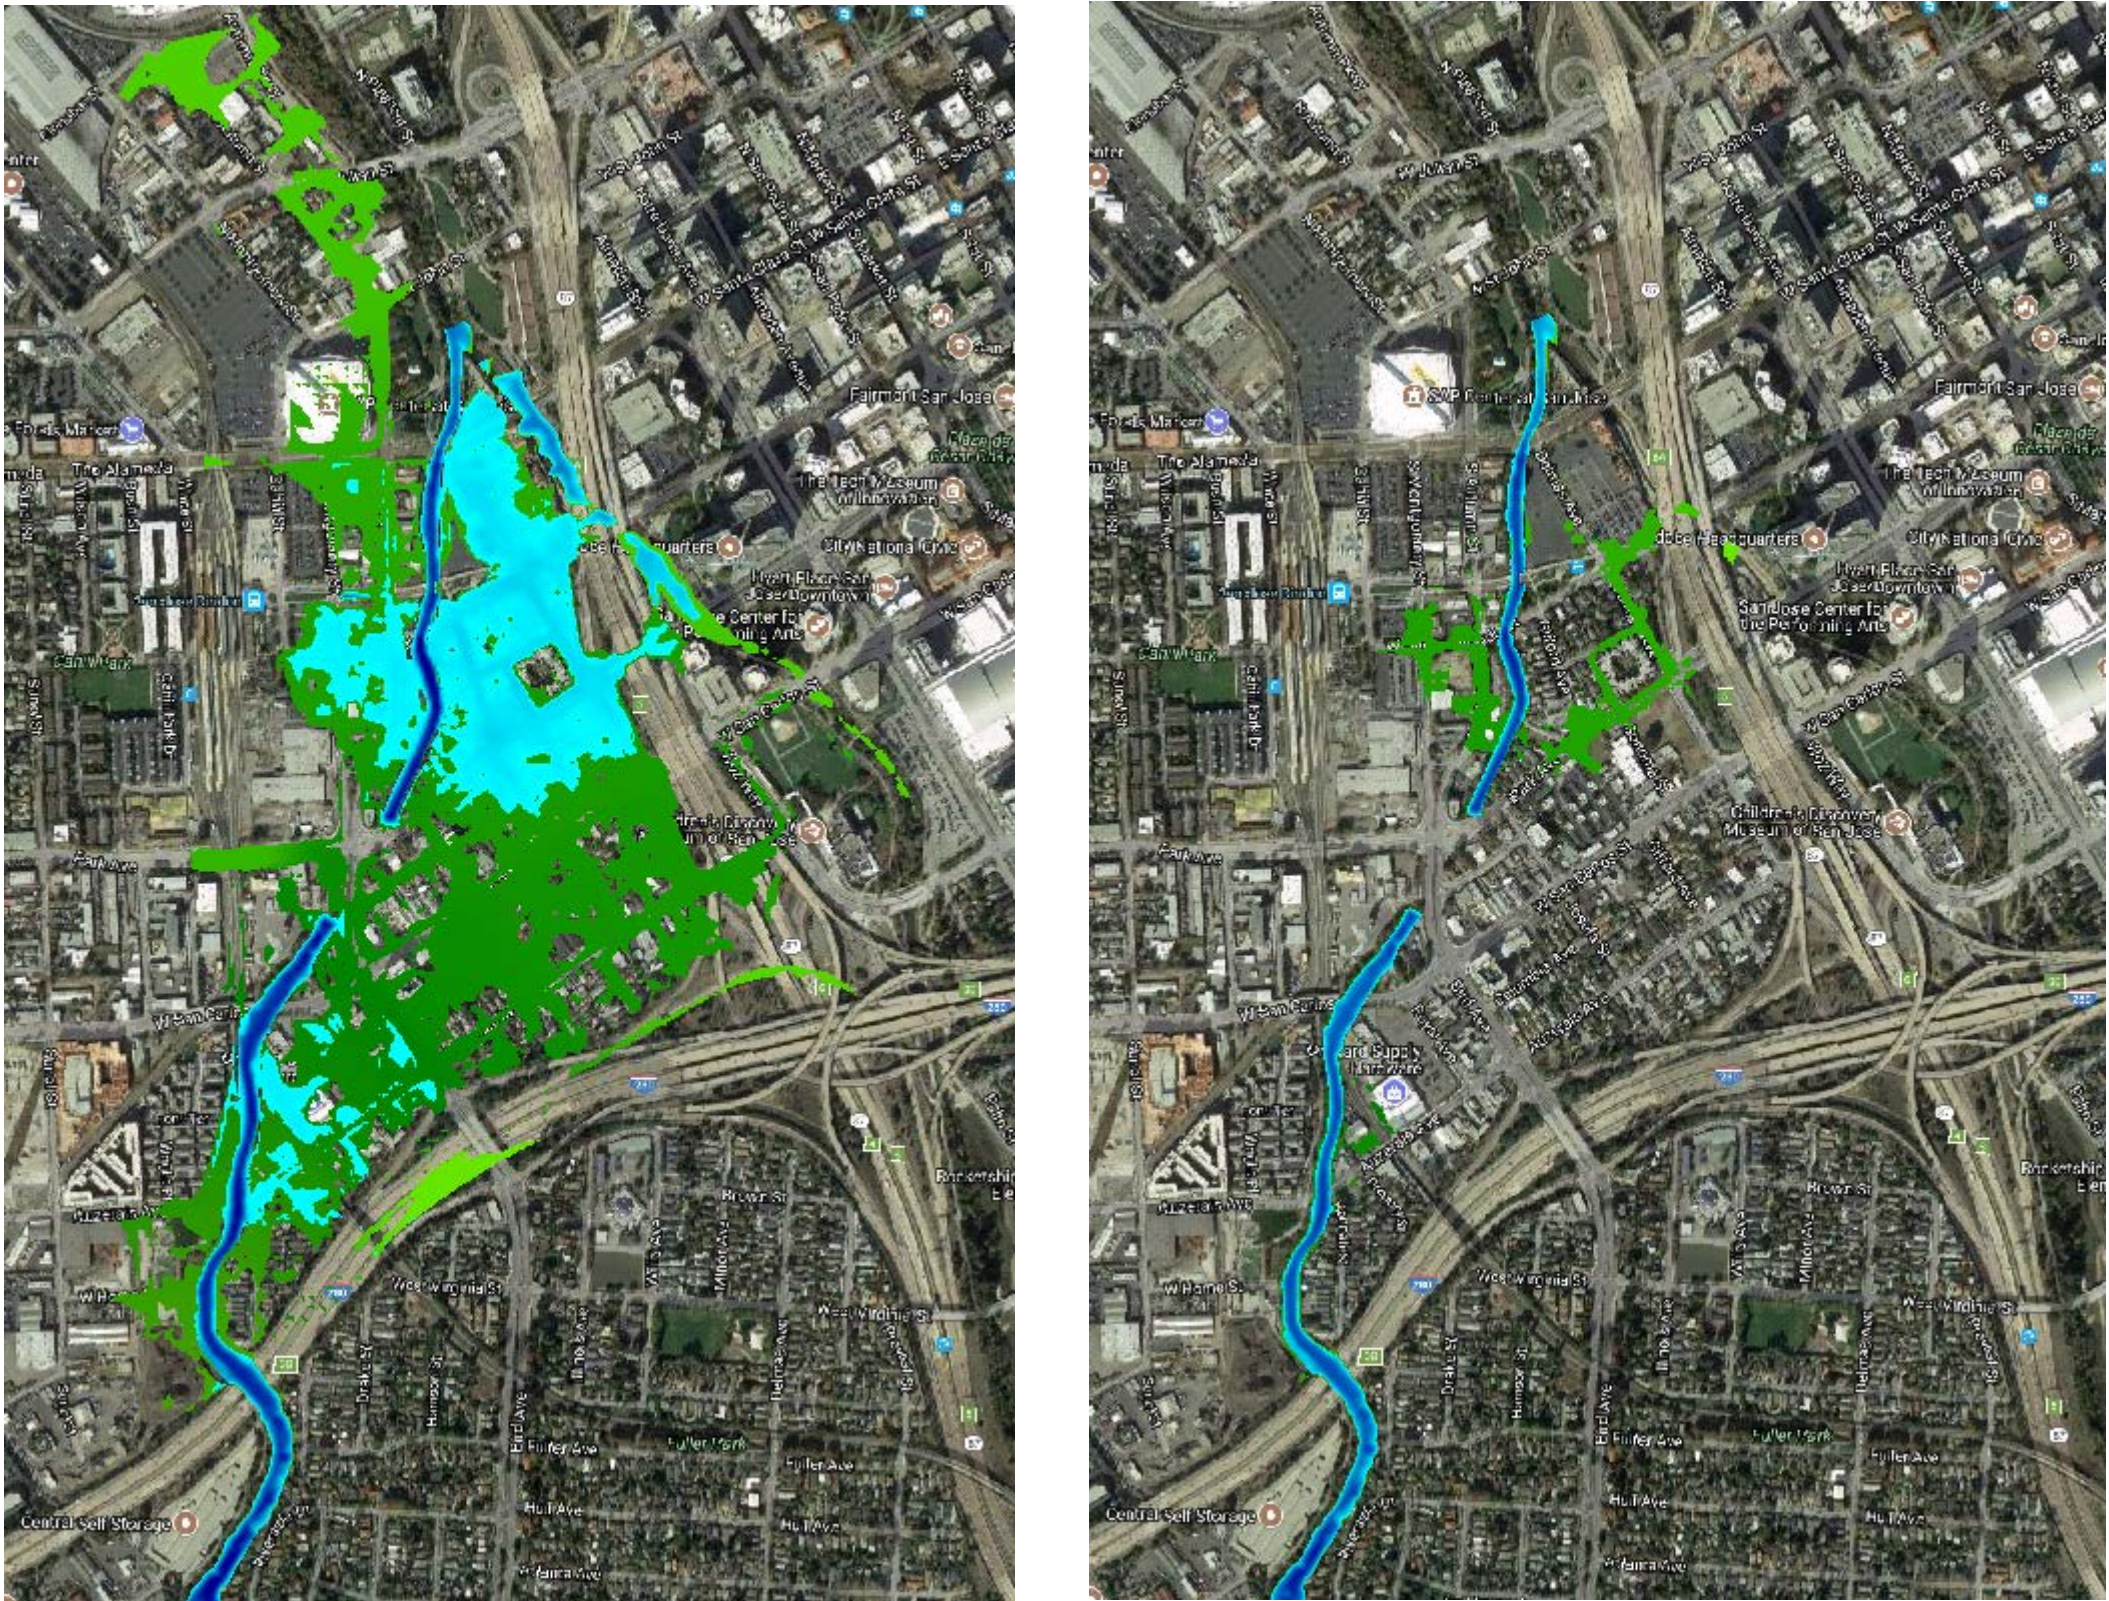
Figure 3: 100yr (Left) and 50yr (Right) Floodplains. (Green footprint is the old model results, blue footprint the new)

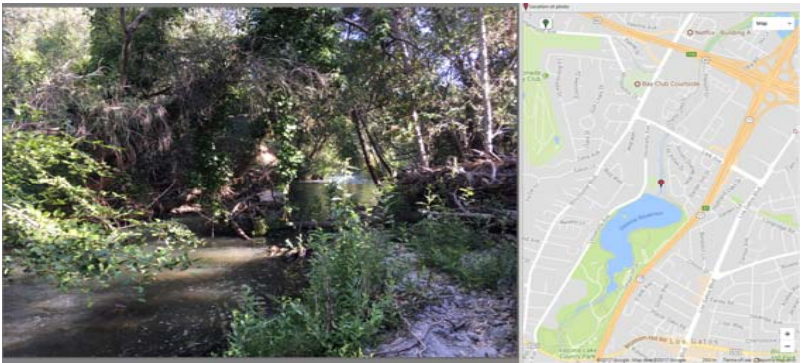
41962.09	Left Bank	Left Floodplain	Main Channel	Right Floodplain	Right Bank	Photo (Looking D/S)
Bed Material, $n_b$	Earth	Coarse	Coarse	Fine	Earth

Irregularity, $n_1$	Minor	Minor	None	Minor	Minor	
Variation, $n_2$	None	None	None	None	None	
Obstruction, $n_3$	Minor	Minor	None	Minor	Minor	
Vegetation, $n_4$	Extreme	Very Large	None	Large	Medium	
Sinuosity, $m$	Minor	Minor	Minor	Minor	Minor	
Manning's $n$	0.1125	0.0915	0.024	0.0805	0.0575

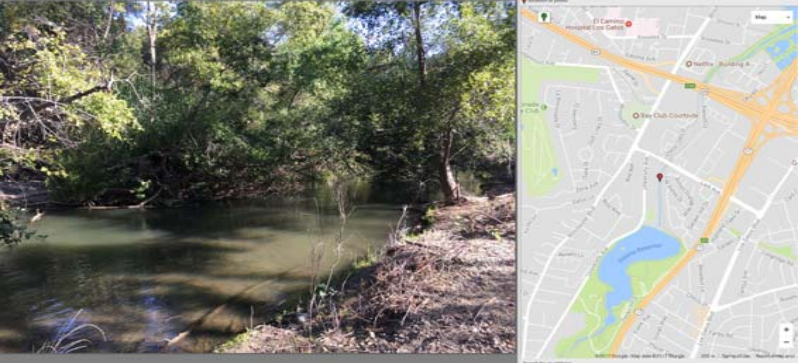
41091.89	Left Bank	Left Floodplain	Main Channel	Right Floodplain	Right Bank	Photo (Looking D/S)
Bed Material, $n_b$	Earth	Earth	Fine	Earth	Earth

Irregularity, $n_1$	Minor	Minor	None	Minor	Minor	
Variation, $n_2$	None	None	None	None	None	
Obstruction, $n_3$	Minor	Minor	None	Minor	None	
Vegetation, $n_4$	Extreme	Extreme	Small	Medium	Medium	
Sinuosity, $m$	Minor	Minor	Minor	Minor	Minor	
Manning's $n$	0.1125	0.1125	0.038	0.0575	0.045

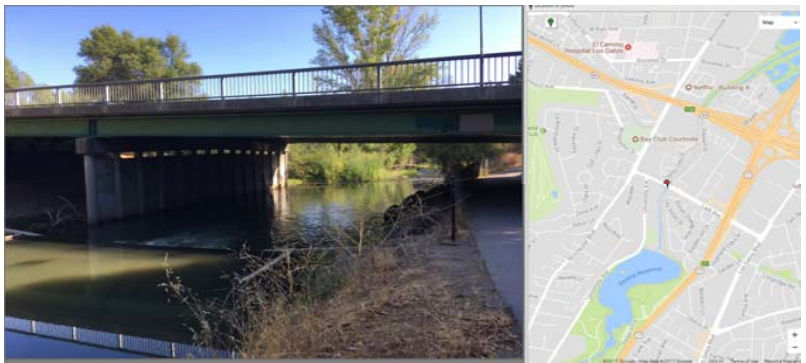
40266.61	Left Bank	Left Floodplain	Main Channel	Right Floodplain	Right Bank	Photo (Looking D/S)
Bed Material, $n_b$	Earth	Earth	Fine	Earth	Earth

Irregularity, $n_1$	Minor	Minor	None	Minor	Minor	
Variation, $n_2$	None	None	None	None	None	
Obstruction, $n_3$	Minor	None	None	None	Minor	
Vegetation, $n_4$	Large	Small	None	Small	None	
Sinuosity, $m$	Minor	Minor	Minor	Minor	Minor	
Manning's $n$	0.0725	0.035	0.028	0.035	0.0375

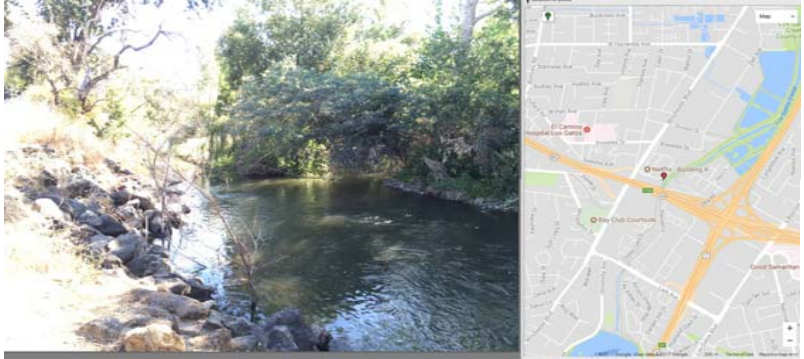
37699.46	Left Bank	Left Floodplain	Main Channel	Right Floodplain	Right Bank	Photo (Looking D/S)
Bed Material, $n_b$	Earth	Rock	Coarse	Fine	Earth

Irregularity, $n_1$	Minor	Severe	None	Minor	Minor	
Variation, $n_2$	None	None	None	None	None	
Obstruction, $n_3$	None	None	Minor	Minor	Minor	
Vegetation, $n_4$	Medium	Medium	None	Large	Medium	
Sinuosity, $m$	Minor	Minor	Minor	Minor	Minor	
Manning's $n$	0.045	0.065	0.0365	0.0805	0.0575

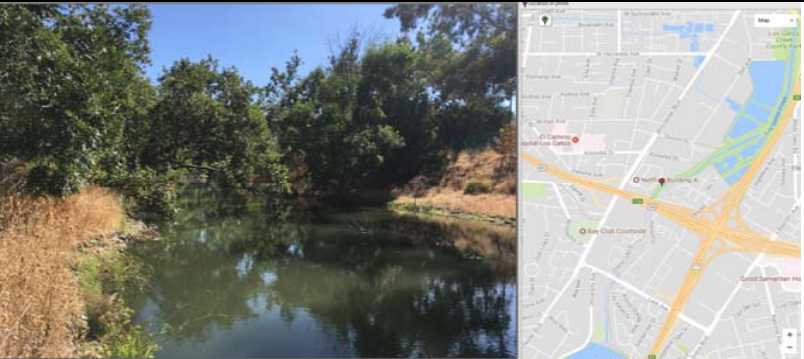
36755.72	Left Bank	Left Floodplain	Main Channel	Right Floodplain	Right Bank	Photo (Looking D/S)
Bed Material, $n_b$	Earth		Fine		Earth

Irregularity, $n_1$	Minor		Minor		Minor	
Variation, $n_2$	None		None		None	
Obstruction, $n_3$	None		None		None	
Vegetation, $n_4$	Medium		None		Medium	
Sinuosity, $m$	Minor		Minor		Minor	
Manning's $n$	0.045	#N/A	0.033	#N/A	0.045

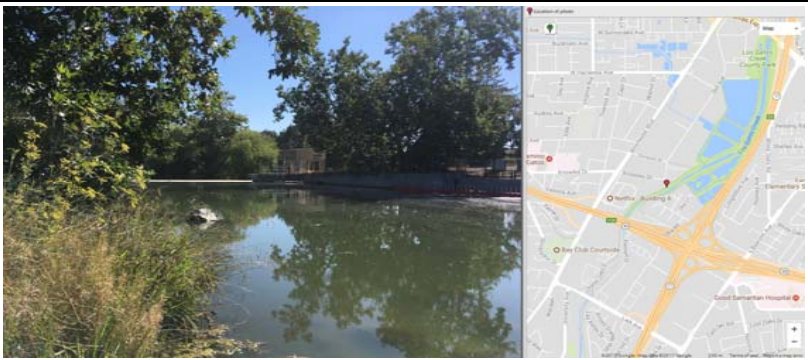
36234	Left Bank	Left Floodplain	Main Channel	Right Floodplain	Right Bank	Photo (Looking D/S)
Bed Material, $n_b$	Earth		Concrete/Dirt		Concrete/Asphalt

Irregularity, $n_1$	Minor					
Variation, $n_2$	None					
Obstruction, $n_3$	None					
Vegetation, $n_4$	Medium					
Sinuosity, $m$	Minor					
Manning's $n$	0.045	#N/A	#N/A	#N/A	#N/A

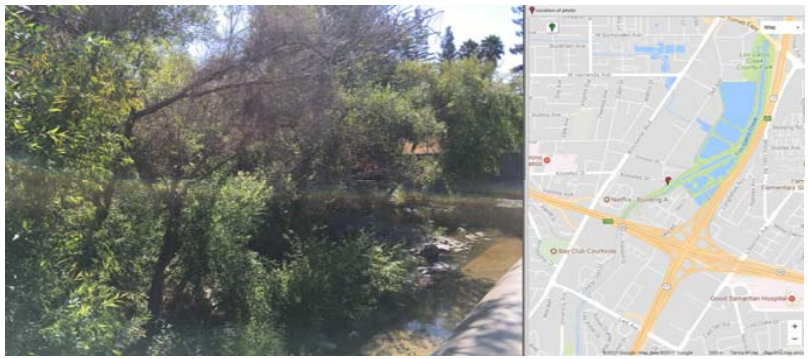
36127.25	Left Bank	Left Floodplain	Main Channel	Right Floodplain	Right Bank	Photo (Looking D/S)
Bed Material, $n_b$			Coarse

Irregularity, $n_1$			Minor			
Variation, $n_2$			None			
Obstruction, $n_3$			Minor			
Vegetation, $n_4$			Very Large			
Sinuosity, $m$			Minor			
Manning's $n$	#N/A	#N/A	0.0915	#N/A	#N/A

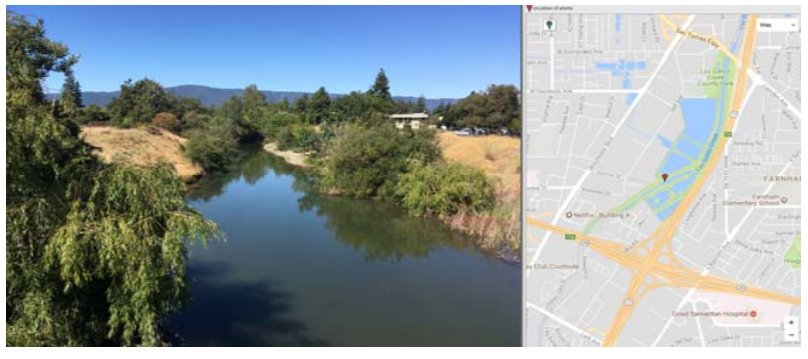
35156.82	Left Bank	Left Floodplain	Main Channel	Right Floodplain	Right Bank	Photo (Looking U/S)
Bed Material, $n_b$	Earth	Fine	Fine	Fine	Earth

Irregularity, $n_1$	None	Minor	None	Minor	None	
Variation, $n_2$	None	None	None	None	None	
Obstruction, $n_3$	None	None	None	None	None	
Vegetation, $n_4$	Small	Medium	None	Medium	Small	
Sinuosity, $m$	Minor	Minor	Minor	Minor	Minor	
Manning's $n$	0.03	0.053	0.028	0.053	0.03

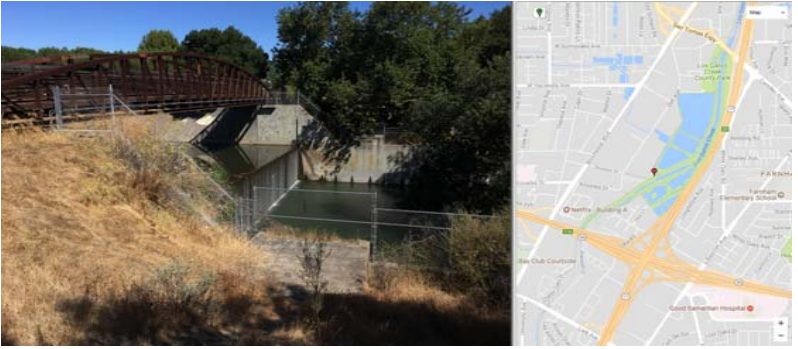
35147	Left Bank	Left Floodplain	Main Channel	Right Floodplain	Right Bank	Photo (Looking @ ROB)
Bed Material, $n_b$	Concrete		Dirt		Concrete

Irregularity, $n_1$						
Variation, $n_2$						
Obstruction, $n_3$						
Vegetation, $n_4$						
Sinuosity, $m$						
Manning's $n$	0.015	#N/A	0.02	#N/A	0.015

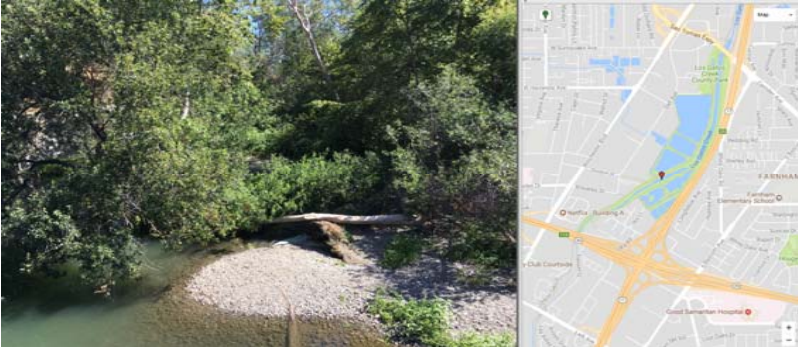
34981.81	Left Bank	Left Floodplain	Main Channel	Right Floodplain	Right Bank	Photo (Looking D/S)
Bed Material, $n_b$	Earth		Coarse		Earth

Irregularity, $n_1$	None		Minor		None	
Variation, $n_2$	None		None		None	
Obstruction, $n_3$	None		Minor		None	
Vegetation, $n_4$	Small		Very Large		Small	
Sinuosity, $m$	Minor		Minor		Minor	
Manning's $n$	0.03	#N/A	0.0915	#N/A	0.03

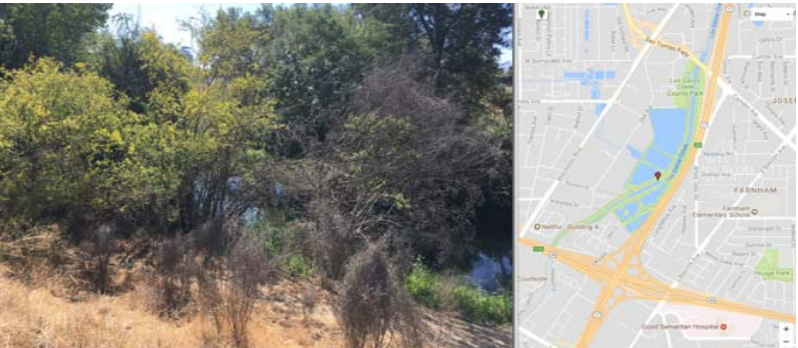
34293.88	Left Bank	Left Floodplain	Main Channel	Right Floodplain	Right Bank	Photo (Looking D/S)
Bed Material, $n_b$	Earth	Fine	Fine	Fine	Earth

Irregularity, $n_1$	None	Minor	None	Minor	None	
Variation, $n_2$	None	None	None	None	None	
Obstruction, $n_3$	None	Minor	None	None	None	
Vegetation, $n_4$	Small	Large	None	Medium	Small	
Sinuosity, $m$	Minor	Minor	Minor	Minor	Minor	
Manning's $n$	0.03	0.0805	0.028	0.053	0.03

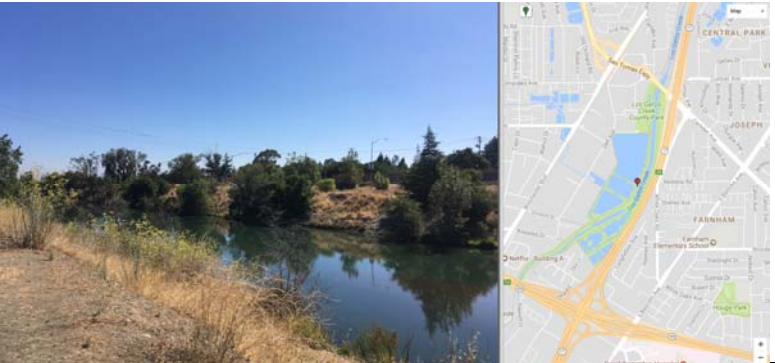
33477.19	Left Bank	Left Floodplain	Main Channel	Right Floodplain	Right Bank	Photo (Looking D/S)
Bed Material, $n_b$	Earth	Earth	Fine	Earth	Earth

Irregularity, $n_1$	None	Minor	None	Minor	None	
Variation, $n_2$	None	None	None	None	None	
Obstruction, $n_3$	None	None	None	None	None	
Vegetation, $n_4$	Small	Medium	None	Medium	Small	
Sinuosity, $m$	Minor	Minor	Minor	Minor	Minor	
Manning's $n$	0.03	0.045	0.028	0.045	0.03

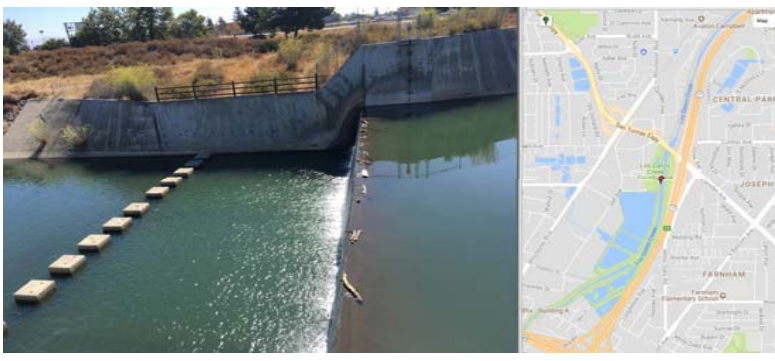
31859	Left Bank	Left Floodplain	Main Channel	Right Floodplain	Right Bank	Photo (Looking D/S)
Bed Material, $n_b$	Concrete		Dirt		Concrete

Irregularity, $n_1$						
Variation, $n_2$						
Obstruction, $n_3$						
Vegetation, $n_4$						
Sinuosity, $m$						
Manning's $n$	0.015	#N/A	0.02	#N/A	0.015

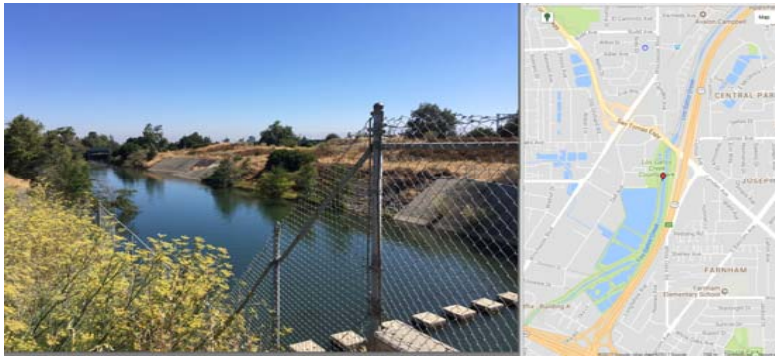
31710.26	Left Bank	Left Floodplain	Main Channel	Right Floodplain	Right Bank	Photo (Looking D/S)
Bed Material, $n_b$	Earth		Fine		Earth

Irregularity, $n_1$	None		None		None	
Variation, $n_2$	None		None		None	
Obstruction, $n_3$	None		None		None	
Vegetation, $n_4$	Medium		None		Medium	
Sinuosity, $m$	Minor		Minor		Minor	
Manning's $n$	0.04	#N/A	0.028	#N/A	0.04

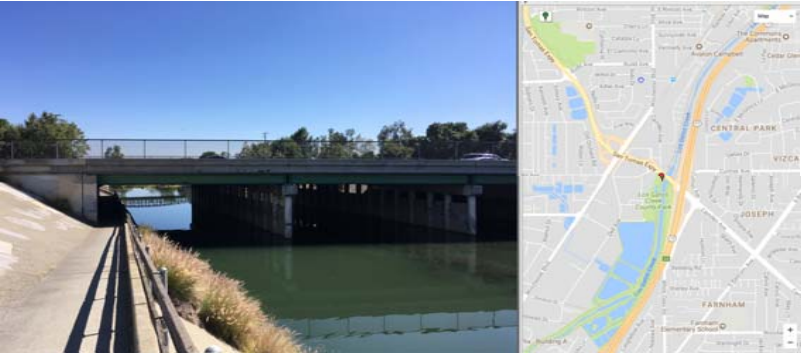
30980.49	Left Bank	Left Floodplain	Main Channel	Right Floodplain	Right Bank	Photo (Looking D/S)
Bed Material, $n_b$	Earth		Fine		Earth

Irregularity, $n_1$	None		None		None	
Variation, $n_2$	None		None		None	
Obstruction, $n_3$	None		None		None	
Vegetation, $n_4$	Small		None		Small	
Sinuosity, $m$	Minor		Minor		Minor	
Manning's $n$	0.03	#N/A	0.028	#N/A	0.03

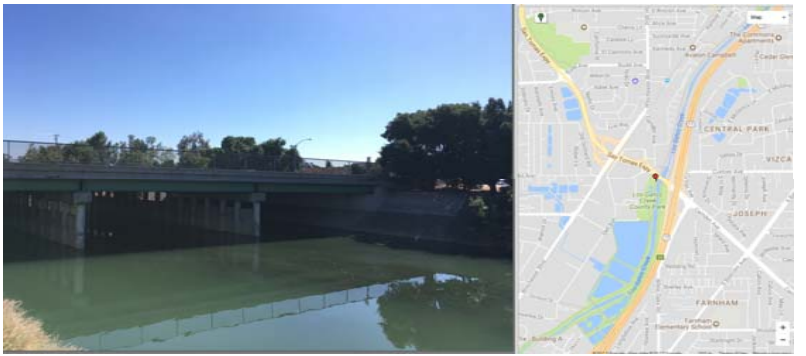
30850.01	Left Bank	Left Floodplain	Main Channel	Right Floodplain	Right Bank	Photo (Looking D/S)
Bed Material, $n_b$	Trail		Concrete		Concrete

Irregularity, $n_1$						
Variation, $n_2$						
Obstruction, $n_3$						
Vegetation, $n_4$						
Sinuosity, $m$						
Manning's $n$	0.03	#N/A	0.015	#N/A	0.015

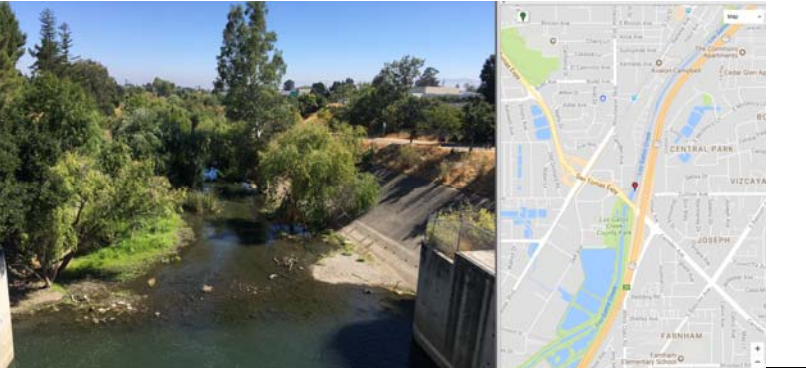
30385.63	Left Bank	Left Floodplain	Main Channel	Right Floodplain	Right Bank	Photo (Looking D/S)
Bed Material, $n_b$	Earth	Coarse	Coarse	Coarse	Earth

Irregularity, $n_1$	Minor	Minor	Minor	Minor	Minor	
Variation, $n_2$	None	None	Minor	None	None	
Obstruction, $n_3$	None	Minor	None	Minor	None	
Vegetation, $n_4$	Medium	Very Large	None	Very Large	Medium	
Sinuosity, $m$	Minor	Minor	Minor	Minor	Minor	
Manning's $n$	0.045	0.0915	0.034	0.0915	0.045

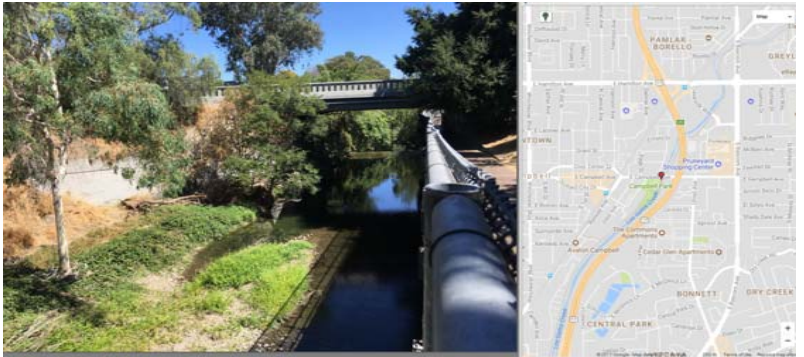
24499.3	Left Bank	Left Floodplain	Main Channel	Right Floodplain	Right Bank	Photo (Looking D/S)
Bed Material, $n_b$	Earth		Coarse		Earth

Irregularity, $n_1$	None		Minor		None	
Variation, $n_2$	Minor		None		None	
Obstruction, $n_3$	None		None		Moderate	
Vegetation, $n_4$	Small		Small		None	
Sinuosity, $m$	Minor		Minor		Minor	
Manning's $n$	0.035	#N/A	0.039	#N/A	0.065

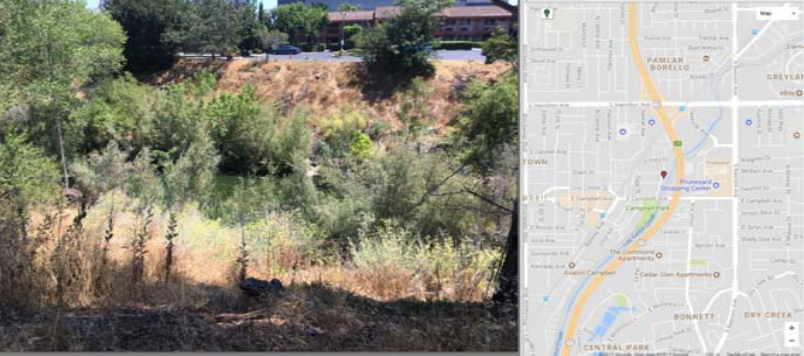
24221.66	Left Bank	Left Floodplain	Main Channel	Right Floodplain	Right Bank	Photo (Looking @ ROB)
Bed Material, $n_b$	Earth	Earth	Coarse	Earth	Earth

Irregularity, $n_1$	Minor	Minor	Minor	Minor	Minor	
Variation, $n_2$	None	None	None	None	None	
Obstruction, $n_3$	None	Minor	None	Minor	None	
Vegetation, $n_4$	Large	Very Large	Small	Medium	Medium	
Sinuosity, $m$	Minor	Minor	Minor	Minor	Minor	
Manning's $n$	0.06	0.0875	0.039	0.0575	0.045

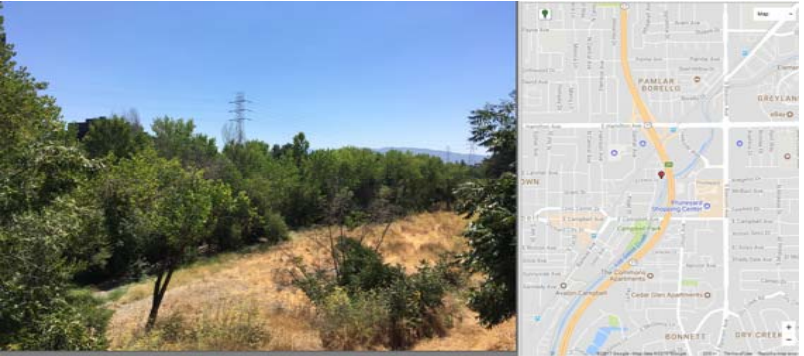
23243.67	Left Bank	Left Floodplain	Main Channel	Right Floodplain	Right Bank	Photo (Looking U/S)
Bed Material, $n_b$	Earth	Earth	Coarse	Earth	Earth

Irregularity, $n_1$	Minor	Minor	Minor	Minor	Minor	
Variation, $n_2$	None	None	None	None	None	
Obstruction, $n_3$	None	Minor	None	Minor	None	
Vegetation, $n_4$	Medium	Very Large	Small	Large	Medium	
Sinuosity, $m$	Minor	Minor	Minor	Minor	Minor	
Manning's $n$	0.045	0.0875	0.039	0.0725	0.045

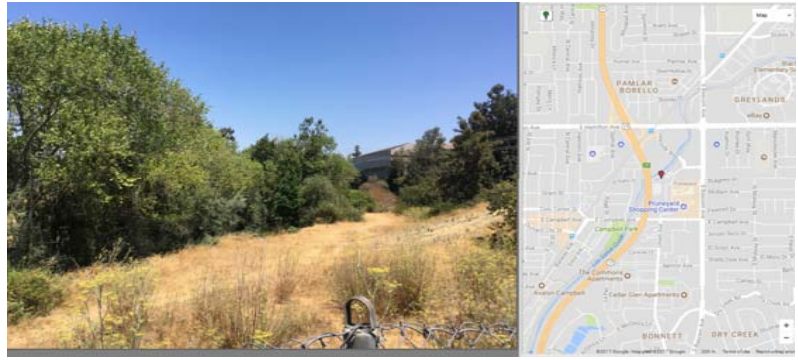
22700.63	Left Bank	Left Floodplain	Main Channel	Right Floodplain	Right Bank	Photo (Looking D/S)
Bed Material, $n_b$	Earth	Earth	Coarse		Earth

Irregularity, $n_1$	Minor	Minor	Minor		Minor	
Variation, $n_2$	None	None	None		None	
Obstruction, $n_3$	None	Minor	Minor		None	
Vegetation, $n_4$	Small	Very Large	None		Medium	
Sinuosity, $m$	Minor	Minor	Minor		Minor	
Manning's $n$	0.035	0.0875	0.0415	#N/A	0.045

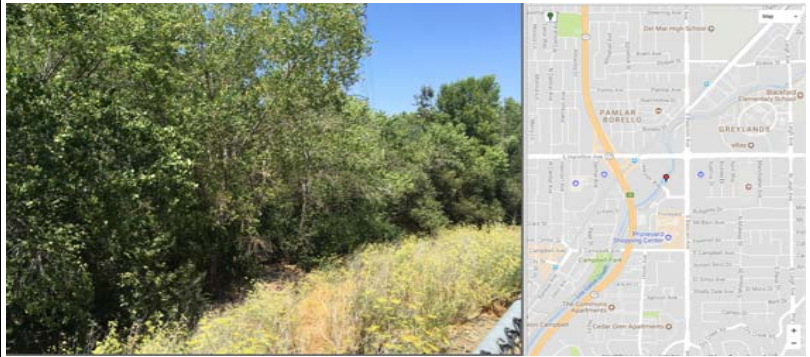
21809.27	Left Bank	Left Floodplain	Main Channel	Right Floodplain	Right Bank	Photo (Looking D/S)
Bed Material, $n_b$	Coarse	Earth	Coarse	Earth	Path

Irregularity, $n_1$	Moderate	Minor	Minor	Minor		
Variation, $n_2$	None	None	None	None		
Obstruction, $n_3$	None	Minor	None	Minor		
Vegetation, $n_4$	None	Large	None	Very Large		
Sinuosity, $m$	Minor	Minor	Minor	Minor		
Manning's $n$	0.034	0.0725	0.029	0.0875	#N/A

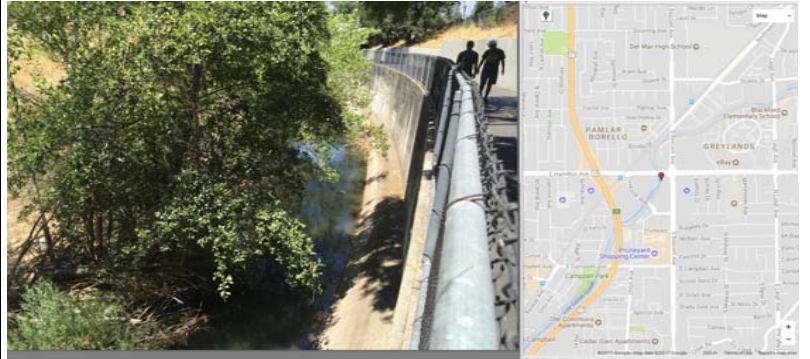
21272.99	Left Bank	Left Floodplain	Main Channel	Right Floodplain	Right Bank	Photo (Looking D/S)
Bed Material, $n_b$	Earth	Coarse	Coarse		Path

Irregularity, $n_1$	Minor	Minor	None			
Variation, $n_2$	None	None	None			
Obstruction, $n_3$	None	None	None			
Vegetation, $n_4$	Medium	Medium	None			
Sinuosity, $m$	Minor	Minor	Minor			
Manning's $n$	0.045	0.049	0.024	#N/A	#N/A

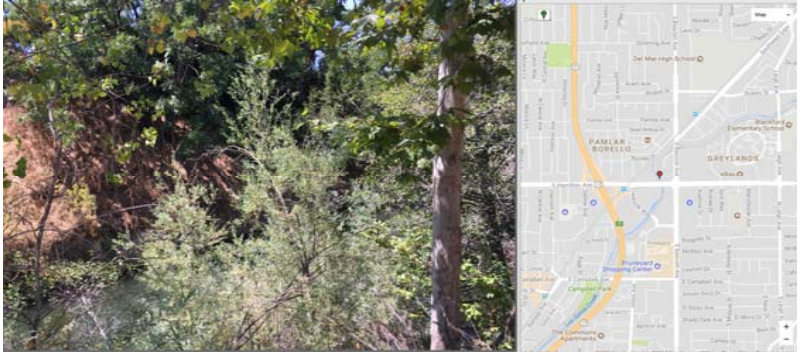
20804.19	Left Bank	Left Floodplain	Main Channel	Right Floodplain	Right Bank	Photo (Looking D/S)
Bed Material, $n_b$	Earth		Earth	Earth	Path

Irregularity, $n_1$	Minor		Minor	Minor		
Variation, $n_2$	None		None	None		
Obstruction, $n_3$	None		None	Minor		
Vegetation, $n_4$	Large		None	Very Large		
Sinuosity, $m$	Minor		Minor	Minor		
Manning's $n$	0.06	#N/A	0.025	0.0875	#N/A

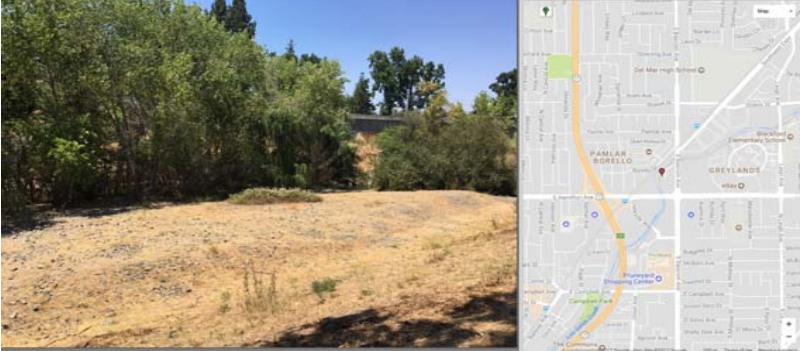
20352.46	Left Bank	Left Floodplain	Main Channel	Right Floodplain	Right Bank	Photo (Looking D/S)
Bed Material, $n_b$	Earth		Earth	Earth	Earth

Irregularity, $n_1$	Minor		Minor	Minor	Minor	
Variation, $n_2$	None		None	None	None	
Obstruction, $n_3$	None		None	None	None	
Vegetation, $n_4$	Medium		None	Very Large	Small	
Sinuosity, $m$	Minor		Minor	Minor	Minor	
Manning's $n$	0.045	#N/A	0.025	0.075	0.035
