## CONTINUATION SHEET

Property Name: 563 W. Julian Street, San José, CA, 95110 (APN 259-27-009)

The following continuation form provides an update to the physical description, property history, and evaluation for the residence at 563 W. Julian Street in San José, California.

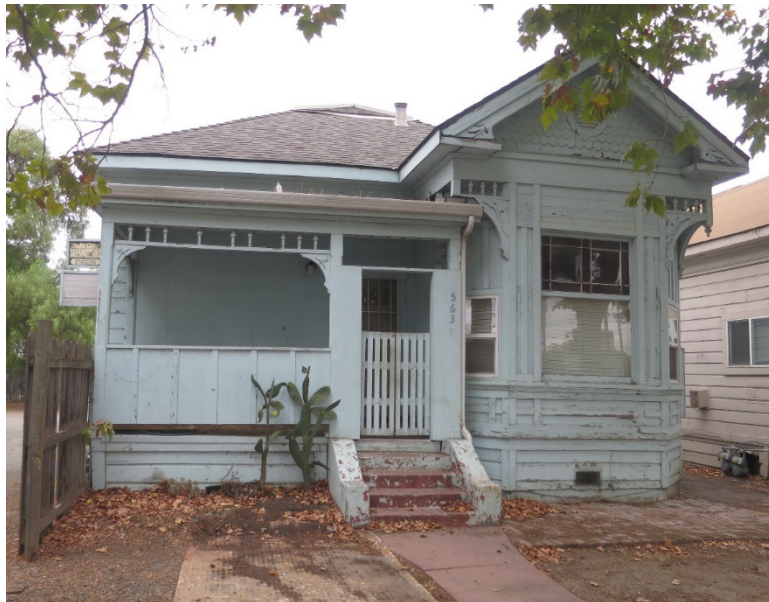
### P5a. Photo

This one-story, Folk Victorian cottage is rectangular in plan and sits on a raised foundation. The wood-frame building has channel drop siding and features an asphalt shingle-clad hipped roof with boxed eaves and a broad rakeboard. A gable-roofed projection with a pierced bargeboard, fishscale shingle siding, and a round louvered vent extends forward from the primary (southeastern) façade. The majority of visible windows have been replaced by vinyl single-hung units that incompletely fill the original window openings, but an original, paired set of double-hung wood windows with ogee lugs is extant on the northeastern façade. A canted bay window is located below the gable roof and decorated with spindlework and brackets. The center unit of the bay appears to be the original one-over-one, wood sash window, with leaded glass in the upper sash. The window units on either side of the bay have been replaced with small single-hung vinyl windows that do not entirely fill the original window openings; the additional space has been infilled with board-and-batten siding. The primary entrance to the dwelling is a single-leaf door covered by a screen door and sheltered beneath a shed-roofed porch on the southern part of the primary façade. The porch is supported by square wood posts and features scroll brackets and a spindlework porch frieze. The original balustrade has been replaced by plywood paneling, and a wood gate has been added at the top of the concrete stoop that serves the porch. Site features include a wood-fenced front yard and tall deciduous trees along the southeastern property boundary.

**P5b. Description of Photo:** South (front) façade, view northwest (September 16, 2019)

Alterations to the residence have been largely limited to the removal of the original porch spindlework and the replacement of several wood windows with vinyl units and plywood infill; however, because the building retains its basic form, roofline, siding, and some detailing, it retains integrity of design, materials, and workmanship. Although the greater vicinity of the property has industrialized since the property's period of significance, it is located within a small complex of three contemporary dwellings that exhibit similar massing and Folk Victorian detailing, and it retains integrity of setting. Through its setting and the retention of these original materials and architectural features, the property maintains integrity of feeling, and because it maintains use as a residential building, it also maintains integrity of association with early nineteenth century residential development in this San José neighborhood.

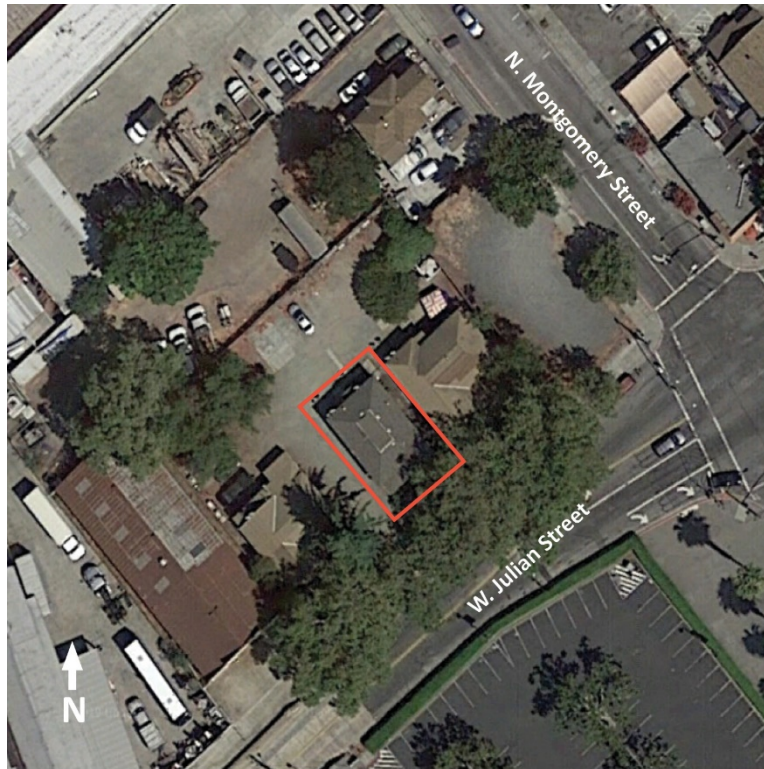
### Sketch Map:

Figure 1. Sketch map of 563 W. Julian Street  
(Google Earth, amended by author)

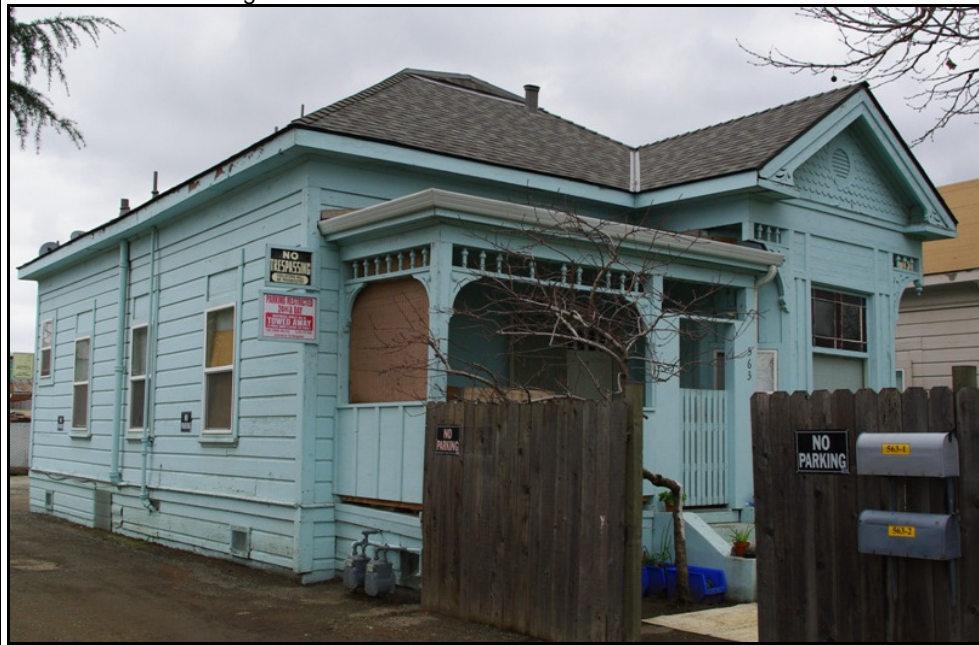
P5a. Photo or Drawing

This one-story residence sits on a raised foundation. It has a hipped roof with a lower cross gable on the primary facade. There is a canted bay window on the right side of the primary facade. A wood entry door is located on the partial width porch which has a flat roof supported by square wood posts, spindle work and brackets. The house is clad in horizontal wood siding except for the canted bay window which is clad in vertical siding. The gable has decorative shingles a louvered vent and a verge board with carvings. One of the two visible windows in the bay is a one-over-one vinyl-sash and the other is a one-over-one wood-sash with colored glass. The vinyl-sash windows replacements along the main and side facades are smaller than the original window openings.

P5b. Description of Photo: View of primary façade on W Julian St., 2/7/2010

The property is not included in the 2009 San Jose Historic Resources Inventory. Alterations to the house include smaller-sized windows, modifications to the porch supports, and a flat roof over the porch that is not typical of Queen Anne style porches. These alterations have degraded the property's historic integrity. The building does not appear to be associated with significant events or trends in local, state, or national history (Criterion A), nor have any of the known owners or occupants during historic times been identified as making significant contributions to the city, state, or nation that are recognized in history (Criterion B). The building is not sufficiently architecturally distinctive for eligibility under Criterion C due to a loss of historic integrity. Additionally, the property has not yielded, and is not likely to yield, important historical information to enable eligibility under Criterion D. Therefore the building is not recommended eligible for listing in the National Register of Historic Places. The building has also been evaluated in accordance with Section 15064.5(a)(2)-(3) of the CEQA Guidelines, using the criteria outlined in Section 5024.1 of the California Public Resources Code. The building is not recommended eligible for listing in the California Register of Historical Resources.
